Ports of Tilbury and Tilbury2 Notice to Mariners – No. 23 of 2019

Ebb Tide Approach – Draft Restrictions

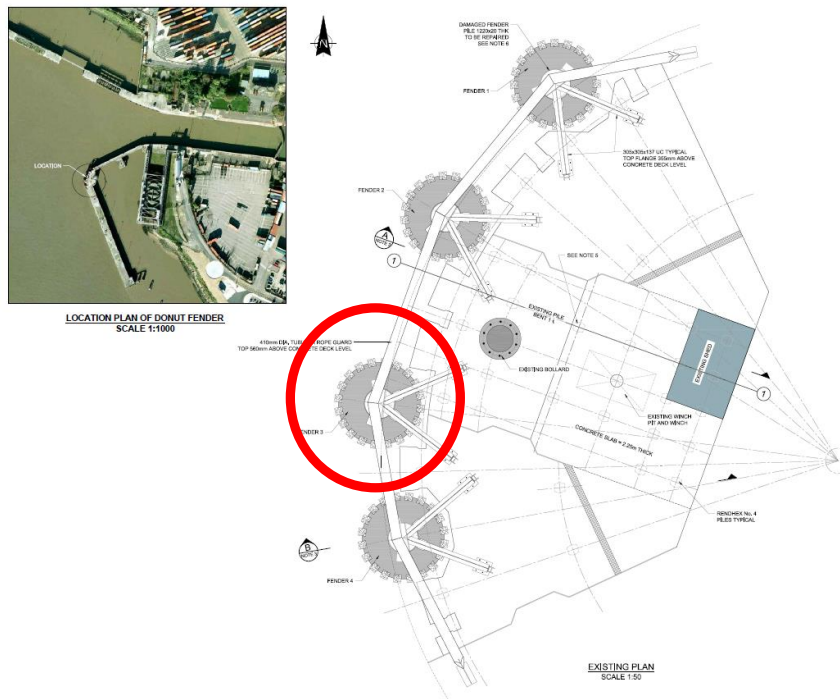
Mariners were advised that No. 3 Donut fender had been damaged and that the roller fender and pile had been temporarily removed. (Notice 21 of 2019)

No.1 and No.2 and No.4 fenders remain afloat and operational, however Mariners are advised to navigate with caution and avoid landing on the donut fenders whenever possible.

A recent survey of the remaining pile structure has shown it to be - 4.8m below CD, therefore a **draft restriction at low water of 4.5m** will be enforced on ebb tide approaches until the pile is replaced.
