Marine Safety Alert

Alert No: 21

Date: 22.02.2022

Unsafe Pilot Support Structures

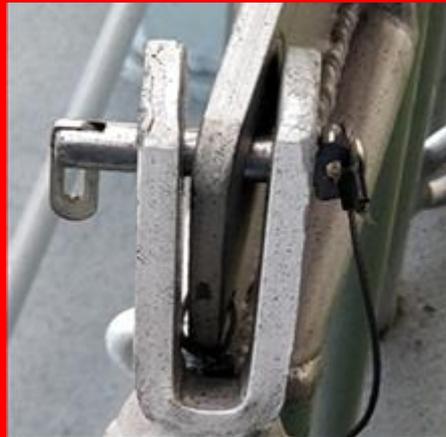
During Pilot boarding activity a handrail supporting the Pilot ladder gave way due to a securing pin working loose. A Pilot had just exited the ladder so no personal injury occurred but the potential for serious injury could be regarded as high / very high.

At the top of the ladder the collapsible handrail on each side was connected to an upright stanchion on the top platform by a short length of curved handrail, which held in place by means of a drop nose pin at each end. See the image above. A video demonstrating how the pin can work loose through simulated ladder vibration is available here

Through examination, it was apparent that the design of the pin with the drop nose ending, is not effective at preventing the pin coming out when the handrail is vibrated transversely due to ladder use.

Whilst it would seem ill advised to stand on the ladder at mid-length to shake the handrail, of more concern in this instance was that there is every possibility that if the ladder should strike the vessel hull during adverse weather, the resulting vibration in the handrail may be sufficient for a correctly installed pin to dislodge with a resultant handrail to collapse.

The same drop nose pin arrangement was present on the other ladders on the vessel thus it was considered as a design fault. This apparent design flaw coupled with the motion induced through ladder use would be highly contributory to this incident.

- Taping up the drop nose, probably effective but tape could detach in poor weather
- Using a cable tie through the slot in the drop pin to prevent the pin being able to come fully out. The tie could even go through the slot and around the rail to prevent any movement of the pin.
- Other solutions are possible, such as wiring the drop nose on the pin or wiring both pins together through their slots. The choice is with the subject vessel at present.

Local Pilots were required to be satisfied that effective temporary solutions were in place prior to disembarkation.

The vessel master was instructed to seek a permanent solution from the ladder manufacturer. This in the hope that it would form part of a general product recall or similar whereby all such ladders (and those of similar design) could be modified to remove the risk.

[All Masters of Vessels calling in the Forth and Tay should check that their ladders are made safe from this potential danger ahead of Pilot boarding/Disembarking.](#)
