## Forth Ports Limited Marine Safety Alert

## Alert No: 25

Date: 2<sup>nd</sup> March 2023

## Pilot Ladders – Safe Rigging

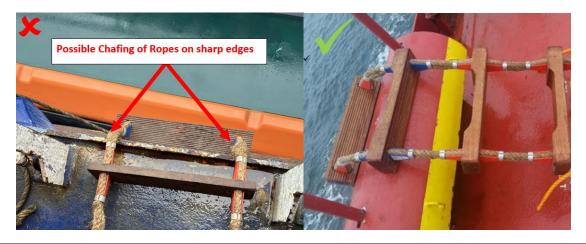
In one instance, a ladder rope parted while there was a Pilot climbing the ladder in a Forth Ports facility due to a lack of edge protection at the point where the ropes passed goes over the edge of the vessel. It has been noted that it is a common occurrence for vessels to have no edge protection in place which causes a significance safety risk for Pilots. Without any protection in place, the ropes can chafe on sharp right angle sections where the rope goes from the deck, over the side of the vessel. Over time, as a pilot puts weight on each rope, the ropes can become worn and eventually cut, potentially causing a very serious incident.

Pilot Ladders should always be rigged with a form of edge protection to stop the ropes from chafing. An Arrangement such as a rounded bar, permanently fixed at the embarkation point should be in place.

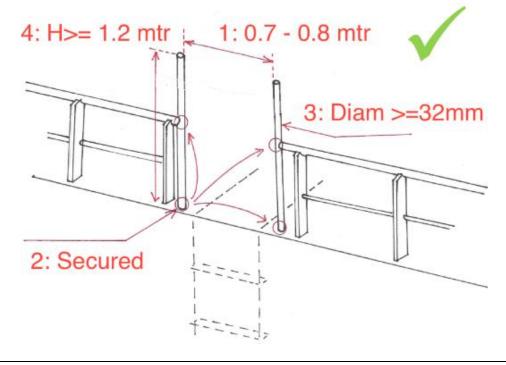
It has also been noted that many vessel do not have stanchions/handholds fitted at the embarkation point as per requirements. Adequate stanchions should be in place to provide a secure handhold for the pilot to pull themselves onto the vessel or to assist with disembarking the vessel as per SOLAS Chapter V Reg. 23 and IMO Resolution A.1045(27) :

- Stanchions to be at least 1.2 metres above the deck/bulwark.
- To be minimum 70 cm and maximum 80 cm apart.
- Stanchions are to have a minimum diameter of 32mm in order to provide a firm grip.
- Each stanchion to be rigidly secured at or near the base and at a higher point.
