## APPENDIX A: Target Notes

| TABLE A1 – OTTER TARGET NOTES | | | | | |

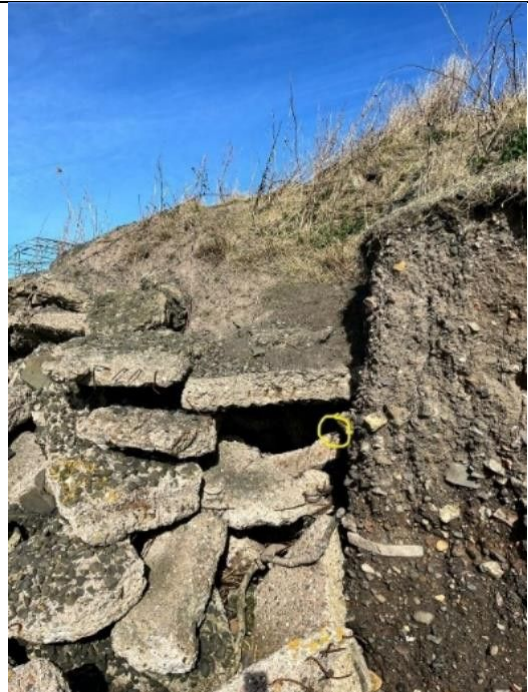
| TABLE A1 – OTTER TARGET NOTES | | | | | |
|---|---|---|---|---|---|
| RS1 | 31/03/25 | NO<br>42703<br>30767 | Potential<br>Holt / not<br>currently<br>a resting<br>site | <p>On top of bank within concrete tipped rubble embedded into bank behind. Gaps appear to lead up into bank which may connect into an old rabbit warren above. Old and recent spraint at entrance (see circled area). Looks approximately 3m from high tide mark.</p> <p><u>Camera monitoring results 7<sup>th</sup> – 29<sup>th</sup> April (22 days)</u></p> <p>Two passes by single otters early in the monitoring period on the 16<sup>th</sup> and 17<sup>th</sup> April and then nothing for the remaining period. One video shows an otter investigating the entrance and another passing by the following night. Based on the monitoring results the feature is not being currently used as a resting site.</p> | |

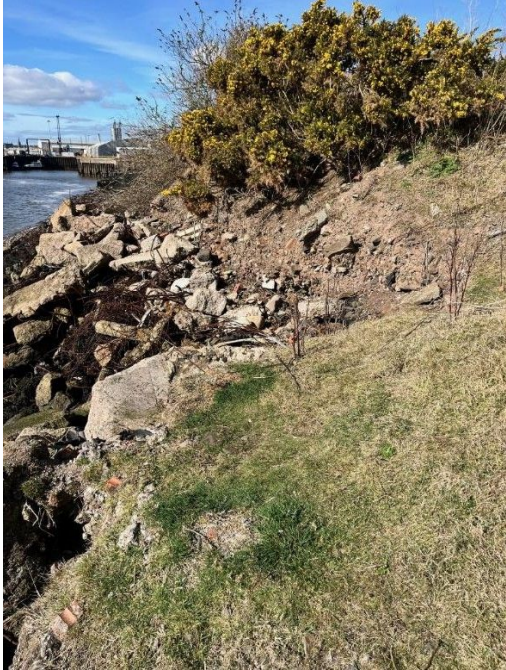
| Spr1 | 31/03/25 | NO<br>42826<br>30759 | Spraint | Spraint site on small grassy promontory with several old spraint, burnt area of grass from urine staining and old fish bones etc. Near to RS2 and RS3. | <p>Patch of bare grass from urine staining.</p> |

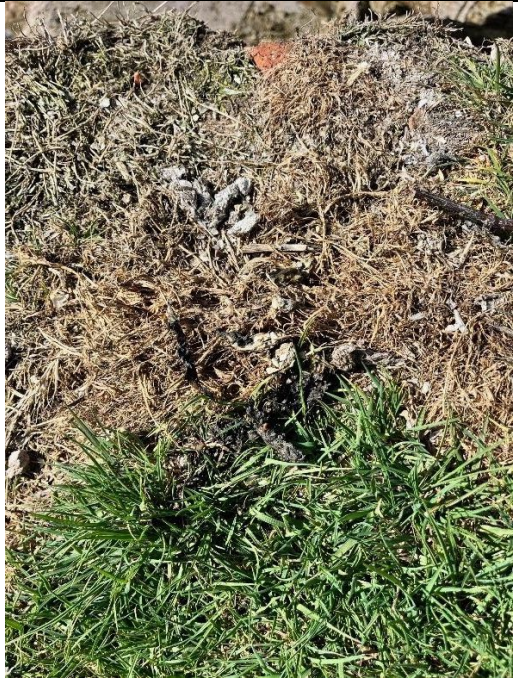
| | | | | | <p>Pile of old spraint near to bare grass patch.</p> |

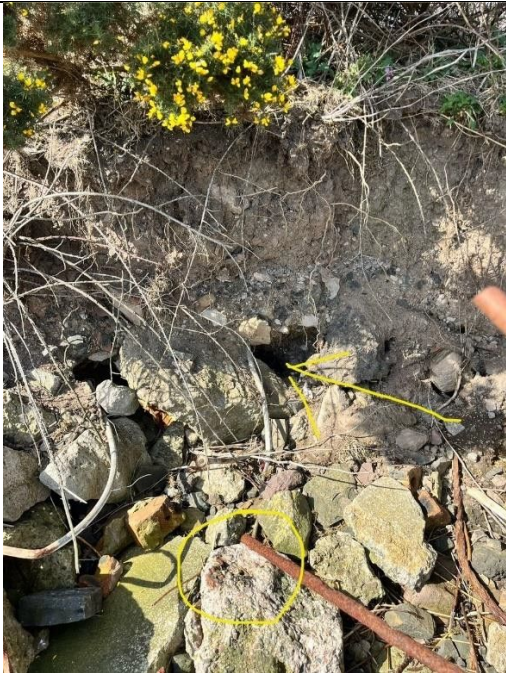
| RS2 | 31/03/25 | NO<br>42836<br>30767 | Potential<br>Holt / not<br>a resting<br>site | <p>Hole into bank under gorse just big enough for otter (see arrow) with vague pathway to it and two old spraint outside (see circled area). Several old spraint on rocks 3m to the north. Approximately 5m above high tide level.</p> <p><u>Camera monitoring results 7th April – 5<sup>th</sup> May (28 days)</u></p> <p>Consistent common rat entries / exits into the feature over the monitoring period. Not considered an otter resting site.</p> | <p>The photograph shows a rocky bank with a hole in the soil, indicated by a yellow arrow. A yellow circle highlights a small, dark, oval-shaped spraint on a rock. The background shows dry vegetation and a yellow flower.</p> |

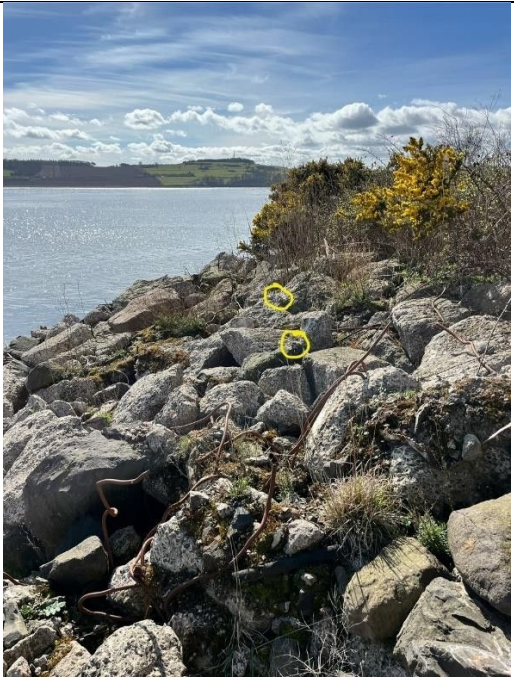
| RS3 | 31/03/25 | NO<br>42835<br>30774 | Holt | <p>7m north of RS2. At least two possible tunnels into rubble pile (and under gorse above) with two associated piles of old spraint. A potential resting site could be anywhere along here but there is a concentration of spraints in this locality although all old. Rabbit droppings also present so tunnels could be attributable to them.</p> <p><u>Camera monitoring results 7th April – 5<sup>th</sup> May (28 days)</u></p> <p>One confirmed diurnal rest on the 27<sup>th</sup> April with a single otter emerging from the entrance in the photo below at 20:44 with dry fur. A potential entry into the holt was noted at a possible new entrance on the 26<sup>th</sup> April at 05:19 but only the tail can be seen disappearing into the rubble.</p> <p>Nine further otter passes were noted over the 28 days with single otters visiting the feature through the night to spraint and scent mark.</p> <p>Foxes and cats were occasional. It is considered the presence of such predators further limits the site to be used for breeding.</p> | <p>Location of RS3 within rubble pile with two spraint sites (circled) at potential entrances to holt under the gorse above. RS2 is located beyond the circled areas at the end of the bank.</p> |

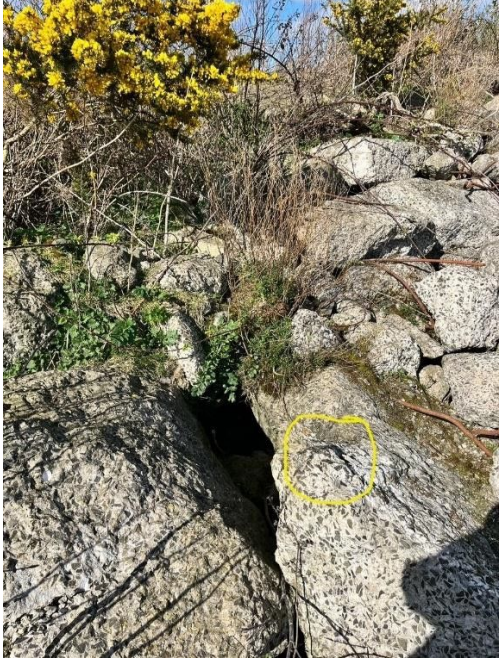
| | | | | | <p>Entrance to RS3 with spraint adjacent (circled).</p> |

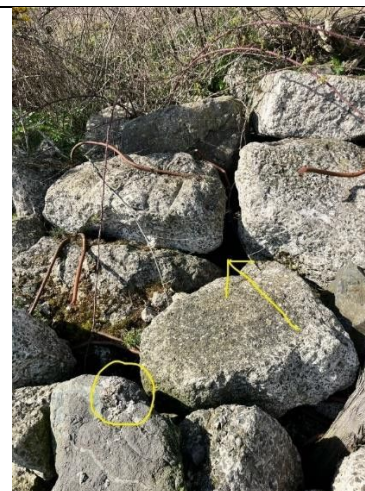
Second potential entrance (arrow) to RS3 with spraint (circled).

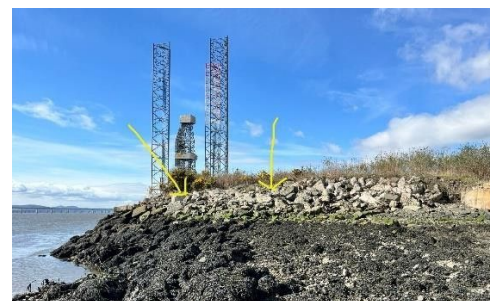
View of rubble pile / rock armour where RS2 (left arrow) and RS3 (right arrow) are located. Also shows the high tide line below

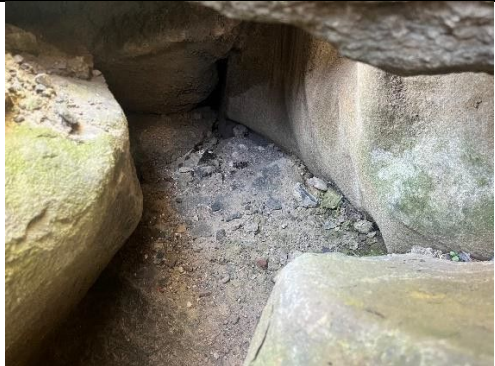
| RS4 | 31/03/25 | NO<br>43436<br>30753 | Couch /<br>Potential<br>holt | <p>Possible couch within rock armour with several recent and old spraint or could be a marker for a holt within the labyrinth of rocks that lies beneath and cannot be fully viewed.</p> <p><u>Camera monitoring results 7th April – 5th May (28 days)</u></p> <p>One entry into the couch from the rock armour above on the 18<sup>th</sup> April at 21:38.</p> <p>Ten further passes of single otters were noted over the 28 day period, through the night and mainly along the shore, spraint / scent marking on occasion and sprainting above the couch on one occasion.</p> | <p>Interior of couch on top of boulder used for rock armour with several recent and old spraint.</p> |

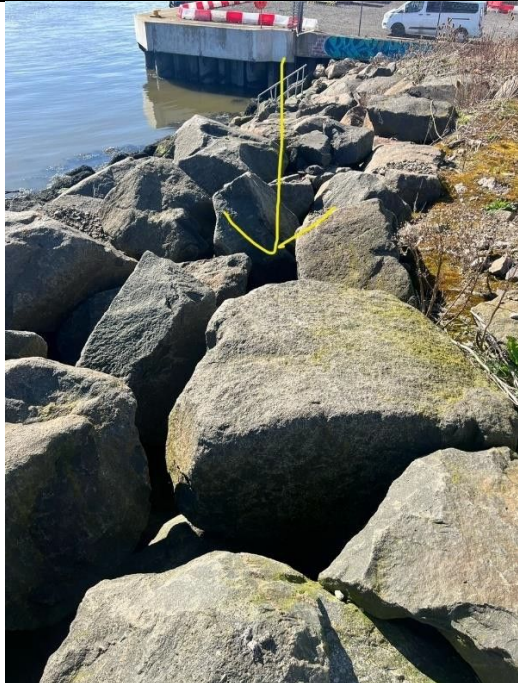
| | | | | <p>Fox passes were occasional and a beaver was noted passing by on one occasion.</p> | <p>Location of couch at the top of the rock armour with old spraint on rock in foreground.</p> |

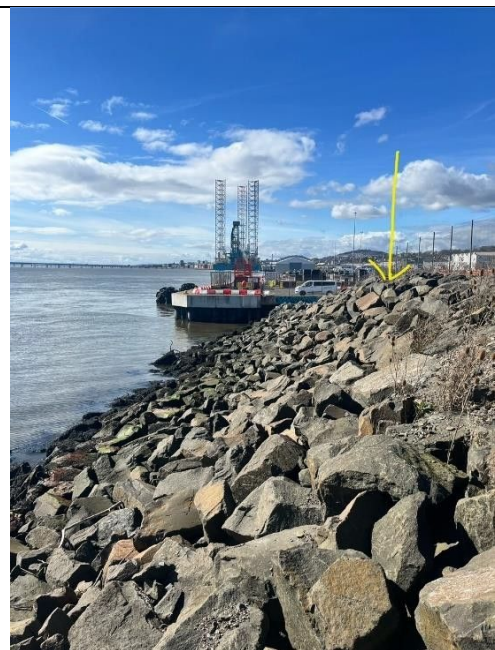
Approximate location of couch likely well above high tide mark.
